## The fireworks disaster in Enschede Part 2: Safety & pyrotechnics

J. Weerheijm \*, R.M.M van Wees \*, P.C.A.M. de Bruyn \*\*, and J.W. Karelse \*\*

Saturday afternoon May 13, 2000 a major fireworks incident occurred at the company S.E. Fireworks in the city of Enschede, the Netherlands. Twenty-two people were killed and more than seven hundred were injured. Within a radius of hundreds of meters houses were destroyed by the blast and debris generated by the explosions and burnt because of the scattered fireworks. Within an hour the incident developed from a moderate fire and some initiating fireworks in one of the buildings into a series of three explosions of increasing violence. Many people witnessed the accident and numerous video recordings from different angles were made.

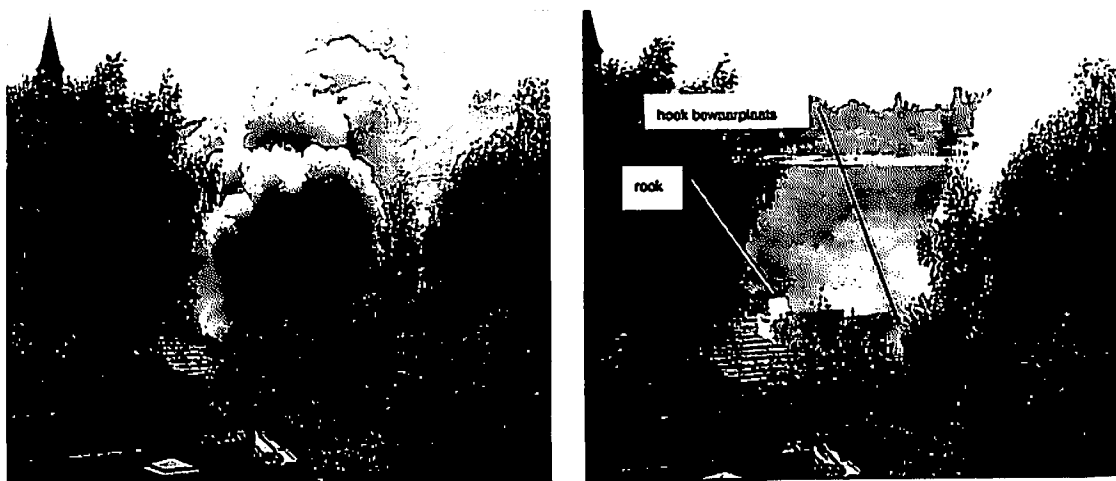
Fig. 2 Effects of E2 reaction (video by G.Poort, enhanced by NFI)

The successive effects of the E2 reaction were: smoke from door slit, strong smoke development followed by intensive firework reactions, flame jet

(in two pulses), ejected fireworks and very severe (external) massive reaction of firework. Similar effects were observed and reported by Merrifield and Myatt<sup>1)</sup> with 1.3G fireworks tests. Figure 2 illustrates these effects.

Ad 3: The first jet had a duration of 2 s and a length of 17 –30 m (distance to central building was 17 m, the jet was deflected upwards leading to a total length of 30 m and a diameter in the order of 20 m). A few seconds later the reaction intensified and a second jet was formed with a length of 35 m and duration of 1 s. The thermal loading on the doors of the other cells and the stored fireworks
