## The fireworks disaster in Enschede Part 2: Safety & pyrotechnics

J. Weerheijm \*, R.M.M van Wees \*, P.C.A.M. de Bruyn \*\*, and J.W. Karelse \*\*

Saturday afternoon May 13, 2000 a major fireworks incident occurred at the company S.E. Fireworks in the city of Enschede, the Netherlands. Twenty-two people were killed and more than seven hundred were injured. Within a radius of hundreds of meters houses were destroyed by the blast and debris generated by the explosions and burnt because of the scattered fireworks. Within an hour the incident developed from a moderate fire and some initiating fireworks in one of the buildings into a series of three explosions of increasing violence. Many people witnessed the accident and numerous video recordings from different angles were made.

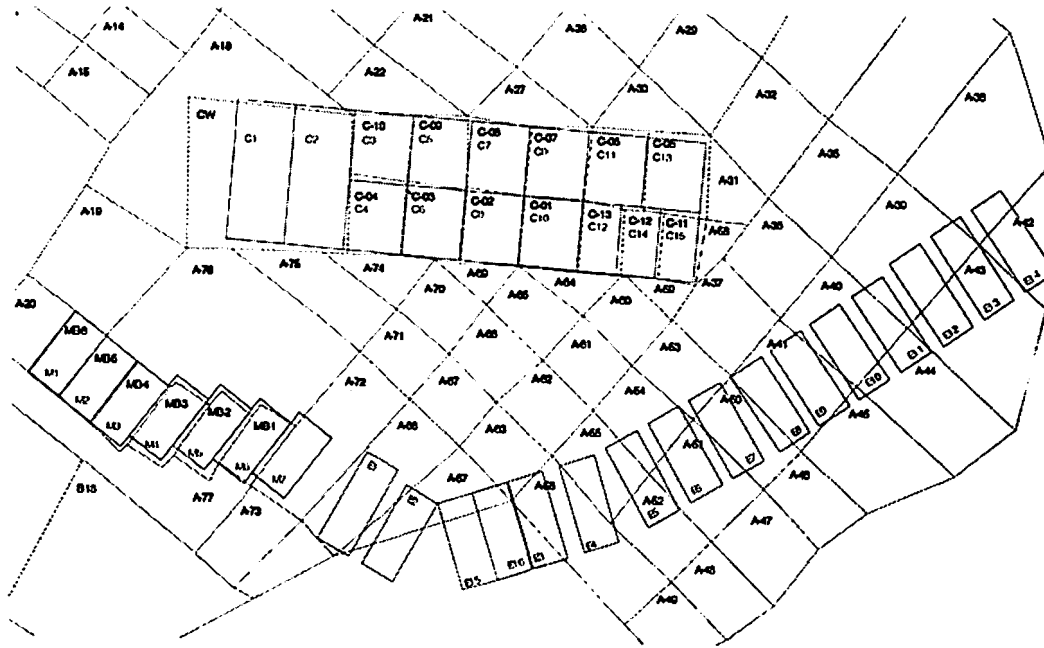
Fig. 1 Scheme of the storage cells and containers of S.E. Fireworks

In the first paper the sequence of events was described. Starting with a fire in the central storage building, the ignition of the fireworks in container E2, within a minute followed by the explosion of the garage boxes and 66 seconds later the devastating explosion in cell C11 of the central building. The layout and identification numbers of the storage cells are given in Fig. 1.
